Substrate and Algae Assessment in the Colorado River and Fraser River Basins 2021

Sediment and Algae Assessment in the Colorado River and Fraser River Basins 2021

Submitted to:
Grand County Learning By Doing
308 Byers Avenue
PO Box 264
Hot Sulphur Springs, CO 80451

Submitted by:
GEI Consultants, Inc.
4601 DTC Blvd., Ste. 900
Denver, CO 80237

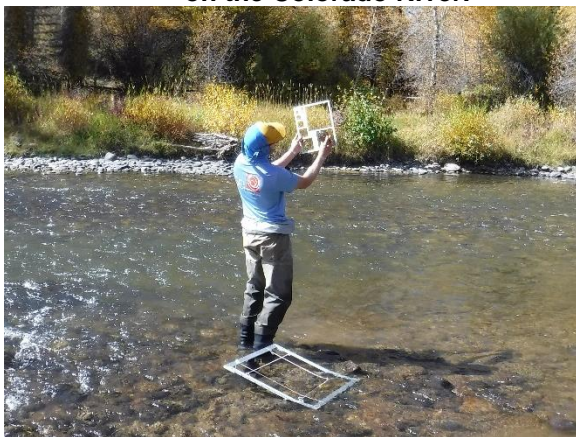
Photo 3-1: Substrate being measured with a gravelometer at Site CR-16.7 on the Colorado River.

At the fourteen sites where pebble counts were performed, the Modified Wolman Pebble Count Method outlined by Colorado Water Quality Control Division (WQCD) Policy 98-1 (Colorado Department of Public Health and Environment [CDPHE] 2014) was utilized. Ten evenly spaced transects were established along a length of stream approximately twenty times the average bankfull width. At each of these ten transects, a 60 by 60-centimeter (cm) sampling frame was used to designate four substrate particles for measurement at ten evenly spaced points across the transect (Photos 3-1 and 3-2). This accounted for a total of 40 substrate particle measurements per transect, and a total of 400 measurements per sampling location. The 60 by 60 cm sampling frame consisted of 4 aluminum bars connected to form a square, with an inside width of 60 cm, and 4 elastic bands placed forming four cross sections with a width of 50 cm. The intermediate axis of each particle designated by the elastic band cross sections on the sampling frame was measured using a gravelometer or ruler (if the particle was too large to fit through the apertures in the gravelometer). Ocular estimates were used for substrate particles that could not be removed from the bed (i.e., due to size). The measured particles were analyzed to determine the D_{50} and the D_{84} of the sample. The notation D represents the particle size in millimeters (mm), and the subscript denotes the percentile; the D_{50} and D_{84} are the diameters (in mm) that are larger than 50% and 84% of the particles in the sample, respectively. The percentage of fine substrate (i.e., < 8 mm) was also calculated to determine the availability of clean substrate and interstitial spaces (i.e., the spaces between gravel and cobble particles used by macroinvertebrates and juvenile fishes).

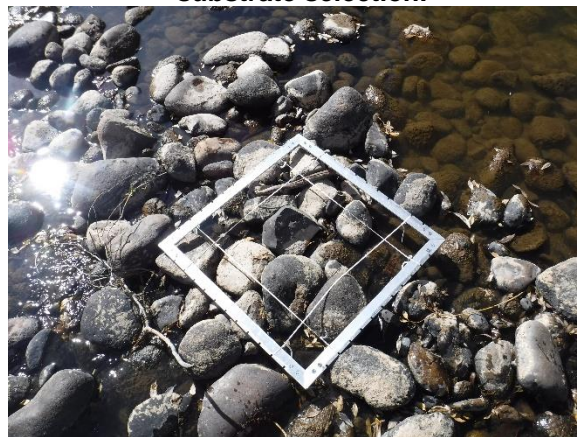
Photo 3-2: Sampling frame with four cross sections for randomized substrate selection.

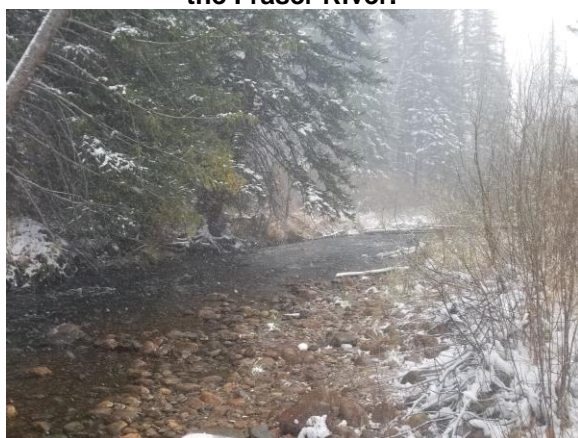
Photo 3-3: An example of a depositional point bar, from Site FR-20 on the Fraser River.

The Riffle Stability Index (RSI) was determined at nine sites using the methods outlined by Kappesser (2002). The RSI value indicates the percentage of mobile bed material in the riffle. A point bar, lateral bar, or similar depositional feature at each site was identified in close proximity to a riffle. A transect was established in a riffle across its bankfull width, and 200 substrate particles were selected. In smaller streams with insufficient width to allow selection of 200 particles, a second transect was established. The intermediate axis of each particle was measured. On the depositional feature, the intermediate axis of 10 to 30 of the largest recently deposited particles were measured, and the geometric mean of these particles was calculated. The geometric mean was then compared to the cumulative distribution of particle sizes from the 200-pebble count in the riffle. This determined the percentage of particles in the riffle that were smaller than the representative large mobile particles in the depositional feature at each site. The mobile fraction on the riffle can be estimated by comparing the relative abundance of various particle sizes present on the riffle with the dominant large particles on an adjacent bar (Kappesser 2002). A point bar, or the accumulation of gravel, cobble, and sand on the inside of a meander bend is a typical depositional feature in the CEA; depositional features at two sampling sites on the Fraser River are shown in Photos 3-3 and 3-4.

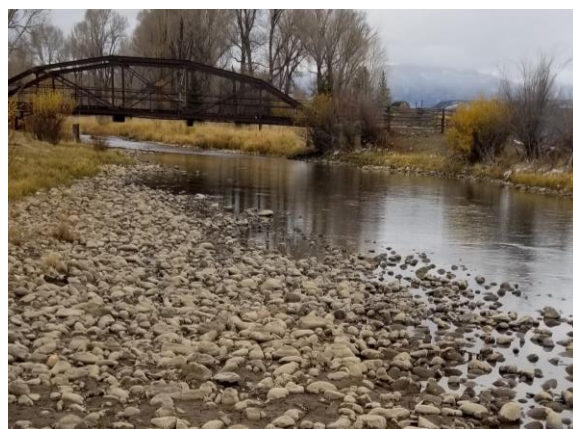
Photo 3-4: An example of a lateral depositional bar, from Site CR-31 on the Colorado River.

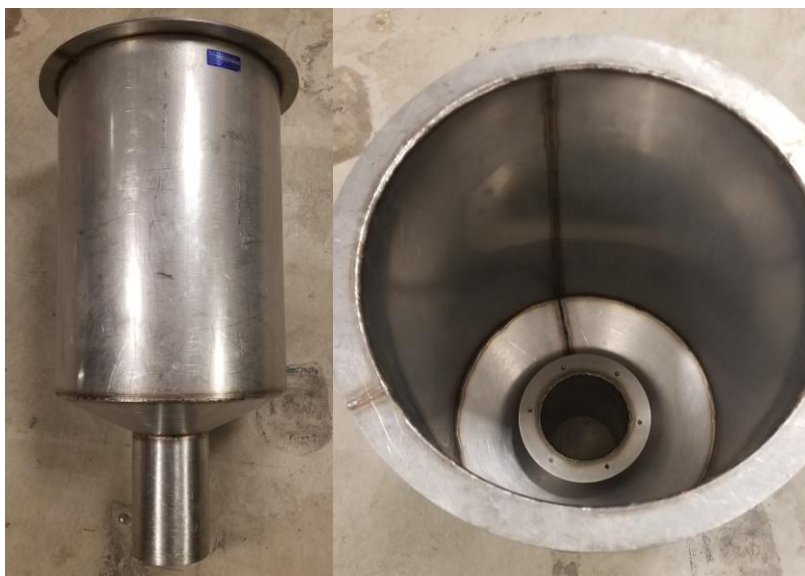
Photo 3-6: Side-view and top-view of the McNeil sampler. Device was driven into the streambed up to the collar and substrate material was removed for analyses from the interior area of the narrow portion.

The amount of fine sediment and the composition of stream gravel were sampled using a McNeil sampler at three sites on the Colorado River, one site on the Fraser River, and one site on Ranch Creek. This sediment data can be used to assess the spawning success of salmonids and other gravel-dependent spawners (McNeil and Ahnel 1964), and channel characteristic data have been used to monitor changes in channel morphology that ultimately affect fish habitat quality over time (Olson-Rutz and Marlow 1992). Six replicate samples were taken from pool tails or low-gradient riffles at each of the sampled sites. Material was removed to the depth of the armor layer, or the layer of clean substrate that forms the top layer of stream substrate and would be moved by salmonids constructing redds, or nests. Substrate material was manually removed from the streambed using the McNeil sampler and brought to the GEI Ecological Laboratory for analyses.
